# Sherlock

# INSPECTION REPORT

Report Number  
Sample Report

Property Location: Address, Town, NJ

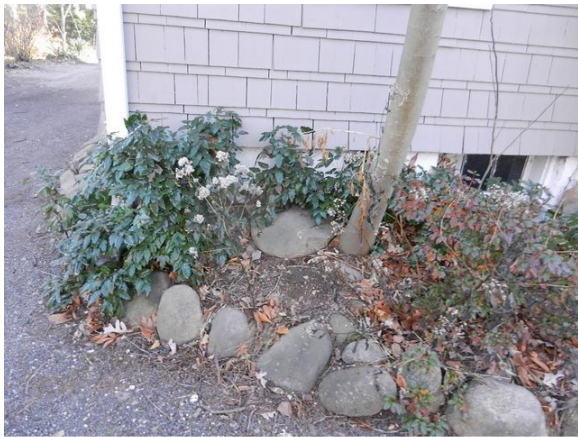
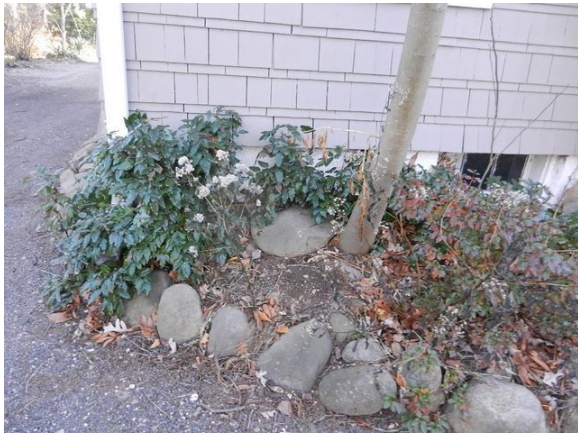
Photo 4

Remove trees at rear of dwelling, close to impeding foundation. See photos 4 and 6.

Rear trees closed to dwelling, recommend removal. See photos 4 and 6.

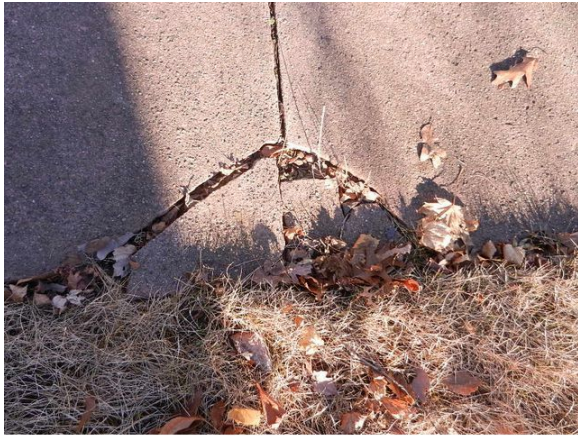
Photo 2

Hairline cracks noted, further evaluate, recaulking/repair is recommended to prevent moisture penetration . See photo 2.

Recaulk/reseal cracking to guard against deterioration due to freeze/thaw cycles which can cause further decay.

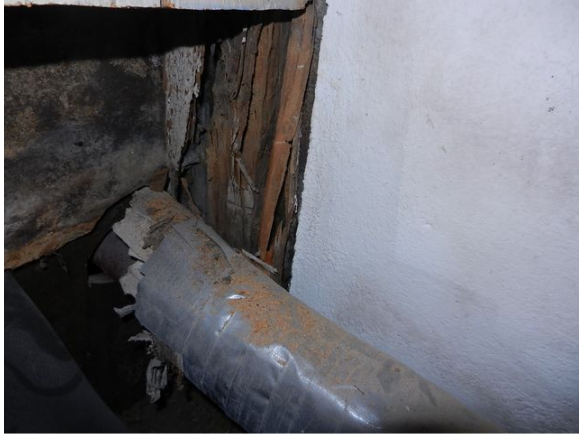
Photo 17

Termite damage on wall studs and sub-floor, consult pest controls, further evaluate for hidden damage. See photos 17.

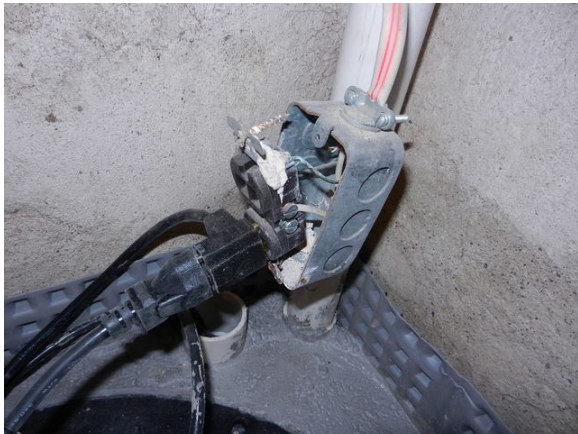
Photo 15

Recommend providing proper electrical box & wiring for sump pump. See photo 15.

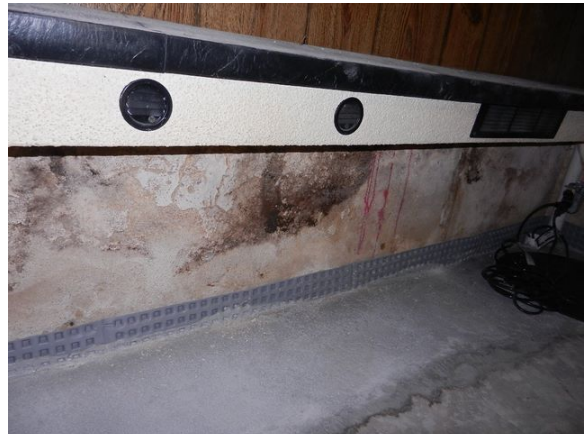
Photo 16

Suspect mold noted on paneled walls. Further evaluation is required as to strain and any environmental hazard it may pose. A swab sample and/or air quality test may be desired. Mitigation may be desired after steps to control moisture have been implemented. See photo 16.

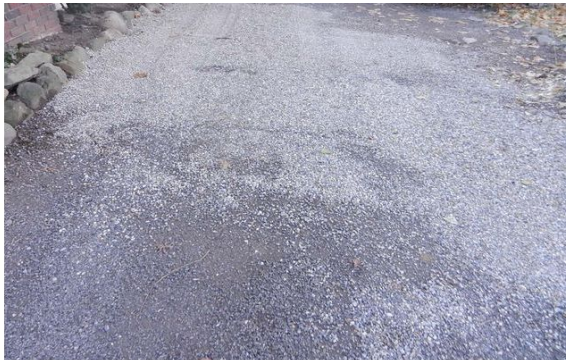
Photo 3

Appears an underground oil tank has been removed, recommend obtaining paperwork. See photo 3.

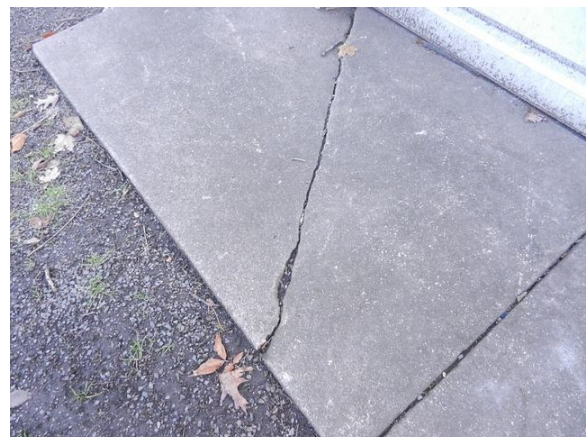
Photo 7

Cracking noted at garage apron. See photo 7.

Consult a contractor for repair cost estimates.

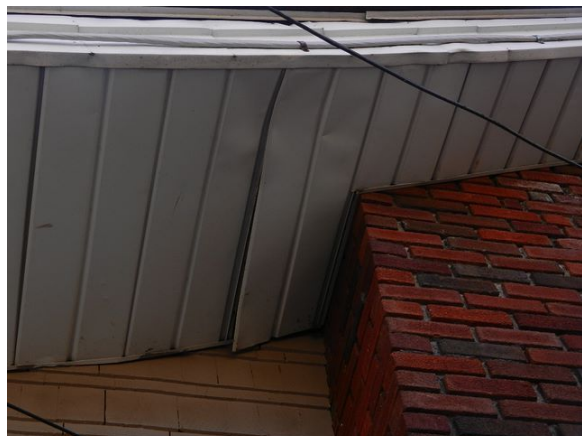
Photo 9

Loose sections were noted at right side soffit, recommend replacing to prevent insect and/or moisture penetration. See photo 9.

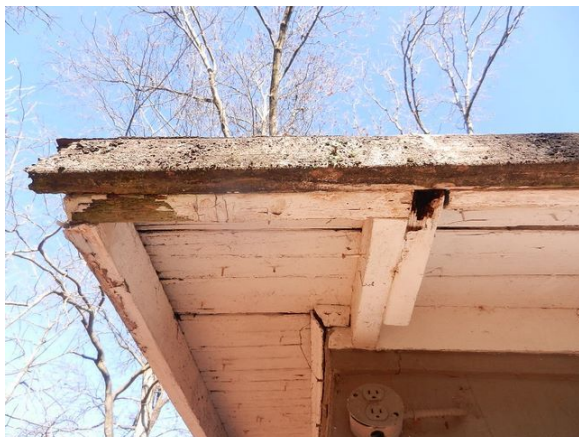
Photo 5

Wood rot/decay noted at tail rafter and fascia board. See photo 5.

Consult contractor for repair cost estimates prior to closing.

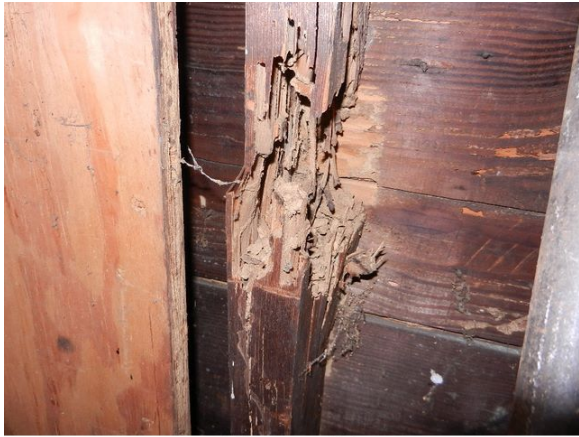
Photo 10

Extensive termite damage at wall studs, consult pest control. See photo 10.

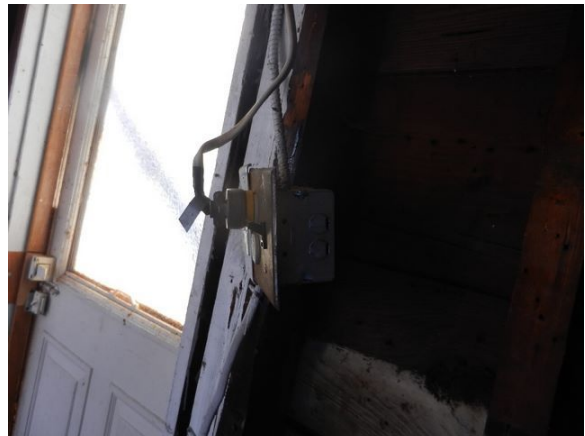
Photo 13

Resecure hanging outlet box. See photo 13.
