Inspection reference: 4900171

INSPECTION REPORT

January 27, 2023

Inspection Location:
Cranbury Station Rd

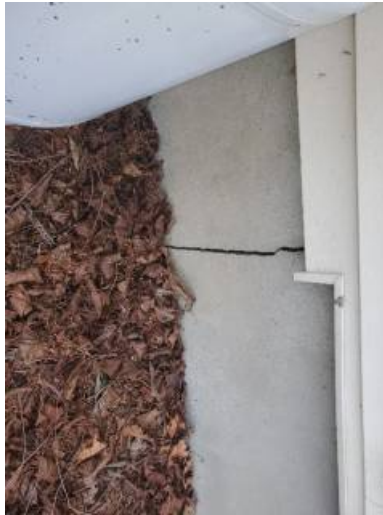
Larger vertical crack noted on the sidewall. Re-sealing is required.

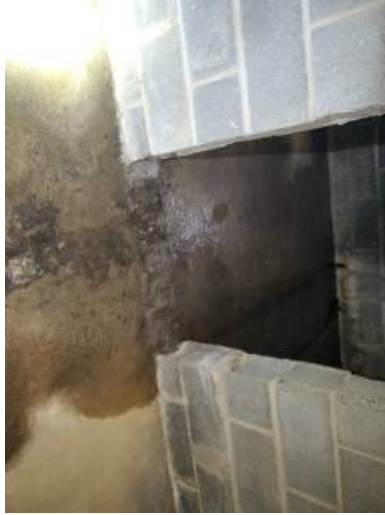
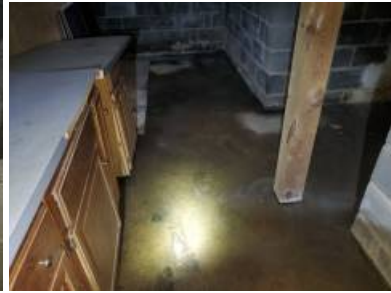
AND Symptoms of prior water entry exist. It should be understood that it is impossible to predict the severity or frequency of moisture penetration on a one time visit to a home. Standing was noted in one section of the basement. The vast majority of basement leakage problems are the result of insufficient control of storm water at the surface. The ground around the house must be sloped to encourage water to flow away from the foundations. Gutters and downspouts should act to collect roof water and drain water at least five feet from the foundation. In the event that basement leakage problems are experienced, lot and roof drainage improvements should be undertaken as a first step. Please be aware of contractors who recommend expensive solutions.

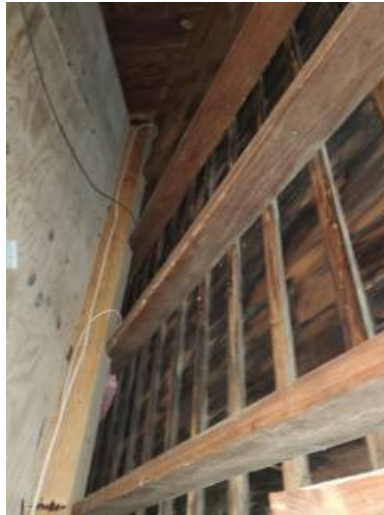
Suspect mold was noted on the front wood shingles under the asphalt roof.

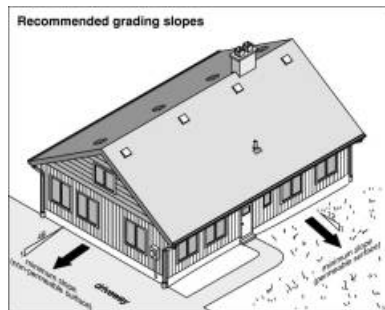
The site is noted to be flat. Grade at foundation needs improvement. Pitch slope of soils away from foundation. Slope should fall away from the foundation at a minimum of 1/2 inch per foot and extend at least four to five feet away from the foundation.

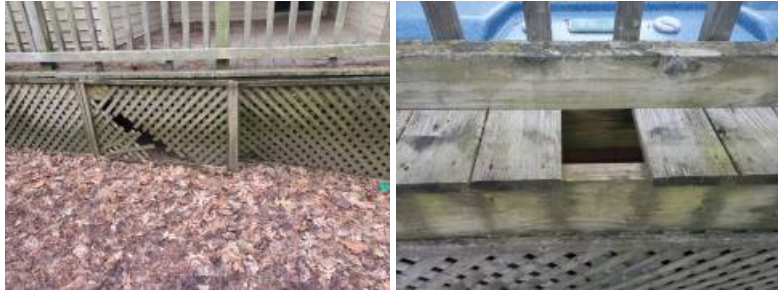
Damaged lattice was noted on the front porch. One piece of missing decking noted on

the back deck.

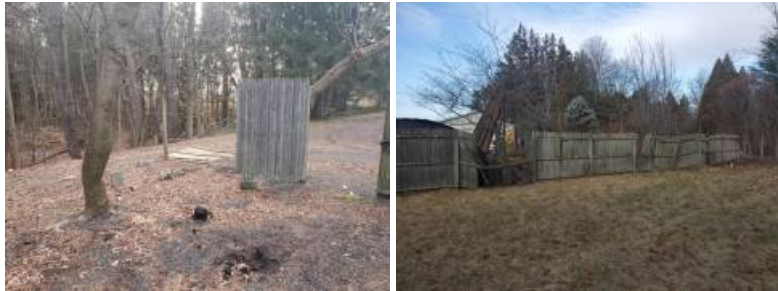
Repairs are required. Rot was noted on sections of the fence. Some replacement is required.

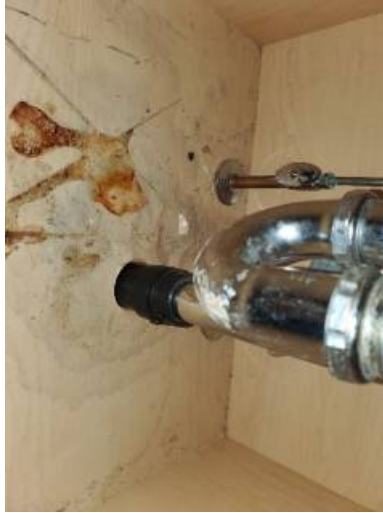
Plumbing under the island sink is deteriorated. Pressure and drainage was not tested.

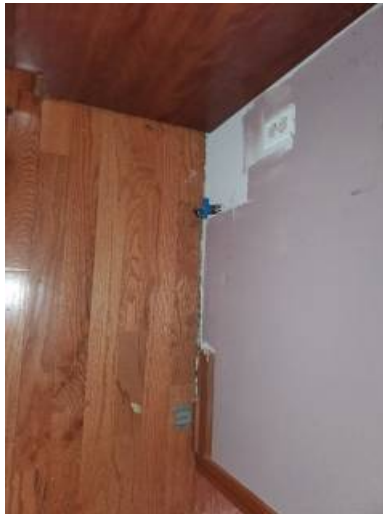
Stove was removed and gas line was not properly capped.

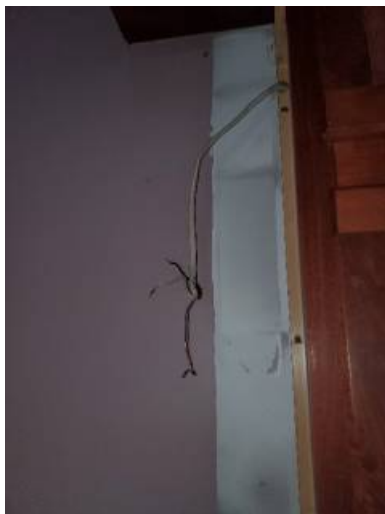
Fan was removed and exposed wires were noted.

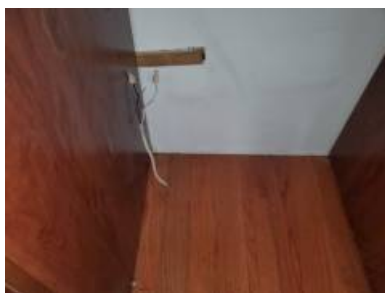
Unit was removed and expose wiring was noted.

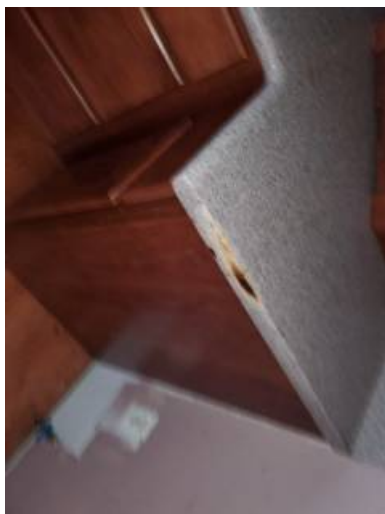
Cabinets appear to be in serviceable condition. Counter was cracked.

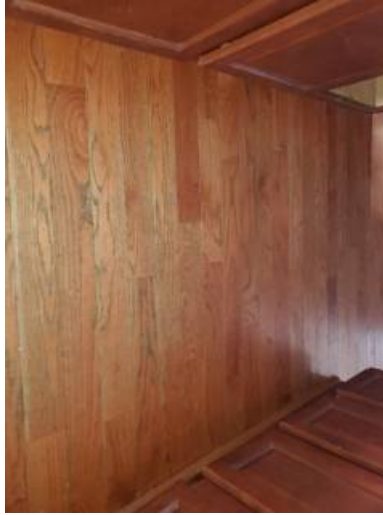
Walls and ceilings appear to be in serviceable condition. The floor covering is wood. Water damage was noted on the wood flooring in front of the kitchen sink.

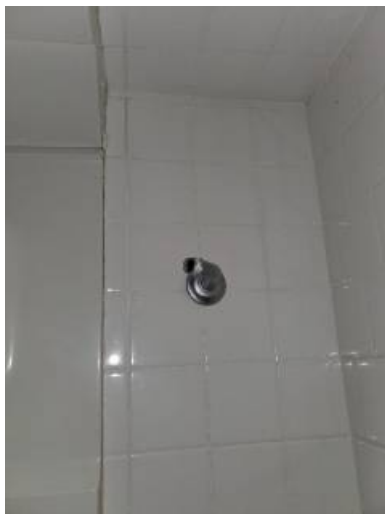
<i>BATH LOCATION:</i>	Upstairs.
<i>CONDITION OF SINK:</i>	Counters/cabinets appear serviceable, Pressure and drainage not tested.
<i>CONDITION OF TOILET:</i>	Toilet was not tested.
<i>TUB/SHOWER FIXTURES:</i>	<i>PLUMBING</i> Bathroom fixtures were not tested. Shower head was missing in the main bathroom.

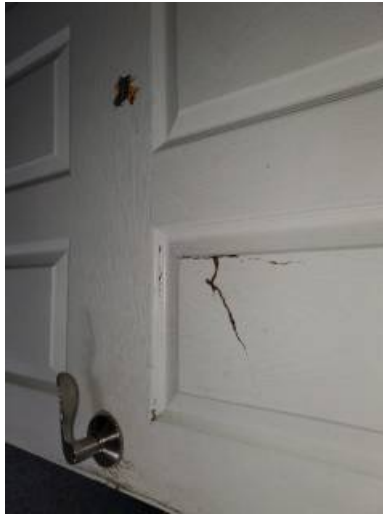
- MAIN ENTRY DOOR:* Appears to be in serviceable condition.
- OTHER EXTERIOR DOORS:* Sliding glass, Appears to be in serviceable condition.
- INTERIOR DOOR ADJUSTMENTS:* *DOOR* Adjustments needed to operate properly. Shaving required on some bedroom doors.
- INTERIOR DOOR CONDITION:* Damage was noted, one bedroom door at the top of the stairs.

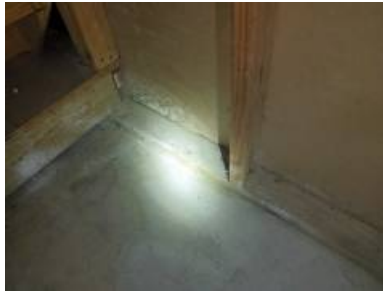
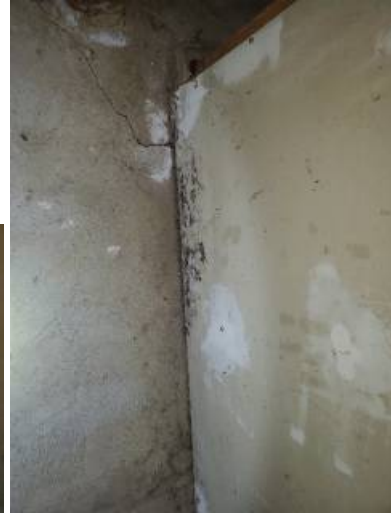
CONDITION: Suspect mold was detected in the home. Staining was noted: on the basement walls and one ceiling.

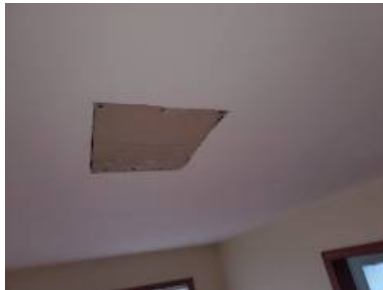
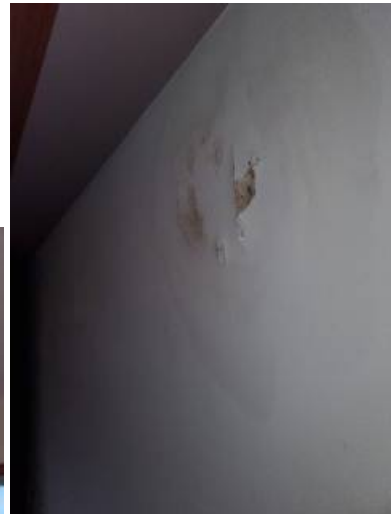
Patching was noted in the family room. Water damage was noted on one spot in the kitchen ceiling.

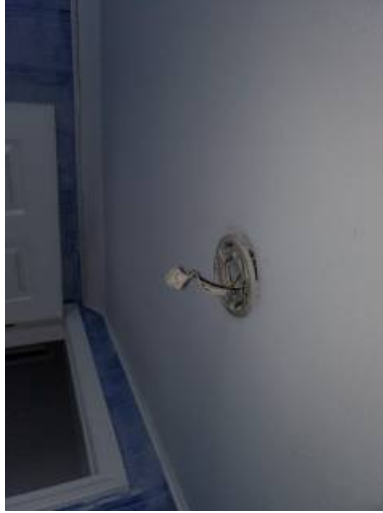
Power was off and detectors were not tested. Units are older and must be updated. Some detectors were missing in the bedrooms and the basement.

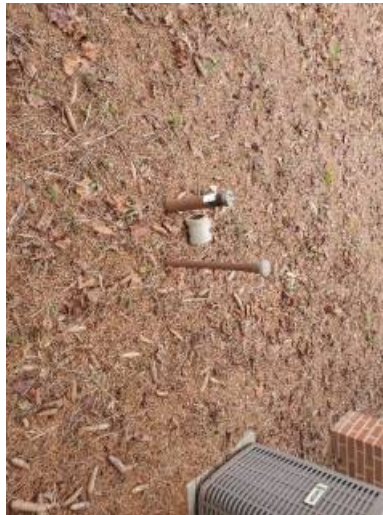
Oil, It is suspected that an underground oil storage tank exists on the property. According to the Environmental Protection Agency(EPA), this situation can represent a significant environmental risk. In most cases these tanks eventually must be removed. Contaminated soil around the tank must be removed. The cost for this work can be substantial. We recommend you test the tank prior to purchase.

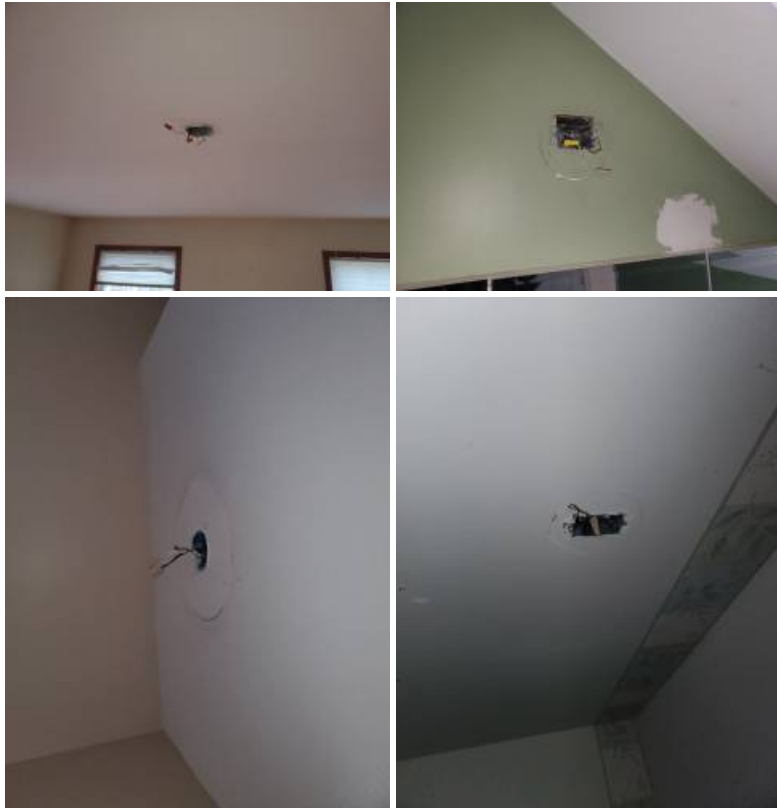
Missing fixtures were noted in the family room, half bathroom, kitchen, dining room, second level stairway, second level bedrooms and the master bathroom.

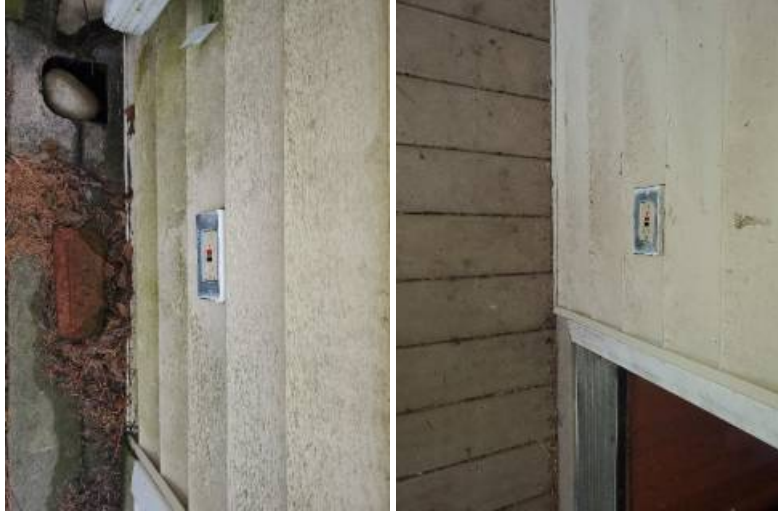
Switches and Outlets were not tested missing weather cover was noted on the rear and side exterior walls. Missing or damaged cover plates viewed.
