Inspection reference: 4900171

INSPECTION REPORT

January 27, 2023

Inspection Location:
Cranbury Station Rd

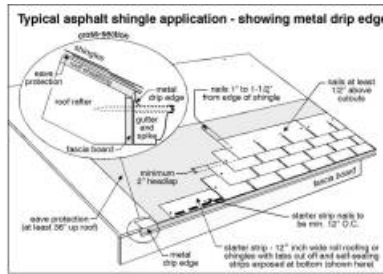
ROOF AGE: 18 plus years.

ROOF ACCESS: The roof was visually inspected from the ground.

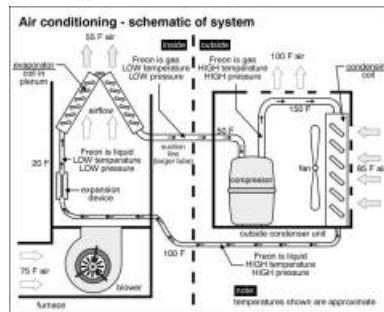
Central, Electric, Outside air temperature was below 65 degrees. Unable to test system at this time. Please note that the air conditioning system is not covered under the warranty until such time as it can be tested.

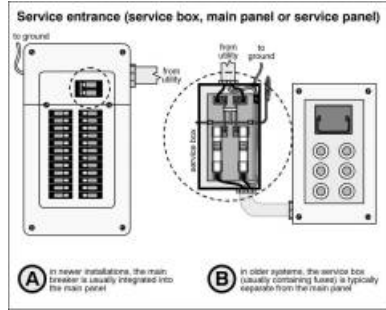
Overhead, 200 Amp, 110/220 Volt, Power was off and the system was not evaluated.
